Storm Water Management Master Plan

VILLAGE OF SUSSEX WAUKESHA COUNTY, WISCONSIN

JANUARY, 2011

Culvert Inspection Reports

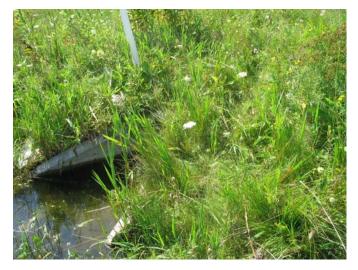
MUNICIPALITY Village of Sussex	PROJECT NUMBER 2092194.100
LOCATION (Road/Intersection) 65' Northwest of SHAPE Round 24-inch MATERIAL Concretion INSPECTED BY: Kyle Zastrow	ete LENGTH 200' COVER (FEET) 3.5
1. Number of Cells: ☐ 1 ☐ 2 ☐ 3 ☐ 4 ☐ 5 ☐ Other	2. Alignment with road: ☐ Perpendicular ☐ Angled NW ☐ Angled SW ☐ Angled NE ☐ Angled SE
3. End Section: ⊠ Spalling, Cracking or Chipping ☐ Rust/Corrosion ☐ Peeling Paint ☐ No End Section	4. Joints: ☐ Spalling, Cracking or Chipping ☐ Corrosion ☐ Rust
5. Headwalls : ☐ Spalling, Cracking or Chipping ☐ Rust/Corrosion ☐ Peeling Paint ☐ No Headwalls	6. Debris:

RECOMMENDED REPAIRS:	
ADDITIONAL COMMENTS:	
Good condition. Joints weren't inspected due to high water levels. (Not found on GIS system)

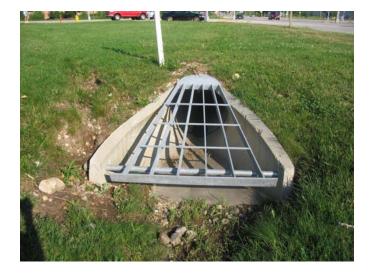
MUNICIPALITY Village of Sussex	PROJECT NUMBER <u>2092194.100</u>
LOCATION (Road/Intersection) Southeast of 16- SHAPE Round 30-inch MATERIAL Concre INSPECTED BY: Kyle Zastrow	4 & Main Street Intersection (ST 223046) tteLENGTH _200'COVER (FEET) 2.5 DATE:7/27/10
1. Number of Cells: ⊠ 1 □ 2 □ 3 □ 4 □ 5 □ Other	2. Alignment with road: ⊠ Perpendicular □ Angled NW □ Angled SW □ Angled NE □ Angled SE to 164
3. End Section: ⊠ Spalling, Cracking or Chipping □ Rust/Corrosion □ Peeling Paint □ No End Section	4. Joints: ⊠ Spalling, Cracking or Chipping ☐ Corrosion ☐ Rust
5. Headwalls: ☐ Spalling, Cracking or Chipping ☐ Rust/Corrosion ☐ Peeling Paint ☐ No Headwalls	6. Debris:

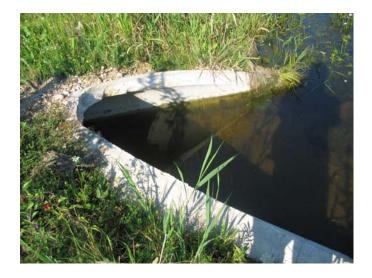
MUNICIPALITY Village of Sussex	PROJECT NUMBER <u>2092194.100</u>		
LOCATION (Road/Intersection) 50' Northwest of 164 & Main Street Intersection (ST 214016)			
SHAPE 30"x38" HERCP MATERIAL Concrete LENGTH 200' COVER (FEET) 3.5			
INSPECTED BY: Kyle Zastrow DATE: 7/27/10			
1. Number of Cells: ☐ 1 ☐ 2 ☐ 3 ☐ 4 ☐ 5 ☐ Other	2. Alignment with road: ☐ Perpendicular ☐ Angled NW ☐ Angled SW ☐ Angled NE ☐ Angled SE		
3. End Section: ☐ Spalling, Cracking or Chipping ☐ Rust/Corrosion ☐ Peeling Paint ☐ No End Section	4. Joints: ☐ Spalling, Cracking or Chipping ☐ Corrosion ☐ Rust		
5. Headwalls : ☐ Spalling, Cracking or Chipping ☐ Rust/Corrosion ☐ Peeling Paint ☐ No Headwalls	6. Debris:

RECOMMENDED REPAIRS:	
ADDITIONAL COMMENTS:	
Good condition. Joints weren't fully inspected due to high water levels.

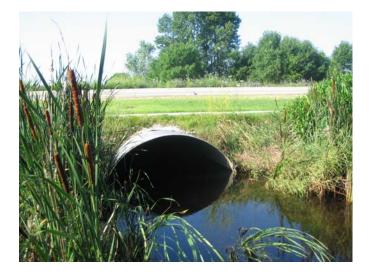
MUNICIPALITY Village of Sussex	PROJECT NUMBER 2092194.100
LOCATION (Road/Intersection) 400' Northwest of SHAPE Round 108-inch MATERIAL CMP	Pewaukee Road/Main Street Intersection (ST 223063 LENGTH 60'COVER (FEET) 2'
INSPECTED BY: Kyle Zastrow	DATE: 7/27/10
1. Number of Cells: □ 1 □ 2 □ 3 □ 4 □ 5 □ Other	2. Alignment with road: ⊠ Perpendicular □ Angled NW □ Angled SW □ Angled NE □ Angled SE
3. End Section: ☐ Spalling, Cracking or Chipping ☐ Rust/Corrosion ☐ Peeling Paint ☐ No End Section	4. Joints: ☐ Spalling, Cracking or Chipping ☐ Corrosion ☑ Rust
5. Headwalls : ☐ Spalling, Cracking or Chipping ☐ Rust/Corrosion ☐ Peeling Paint ☐ No Headwalls	6. Debris:

ADDITIONAL COMMENTS:	
Good condition. Rust is only small amounts.

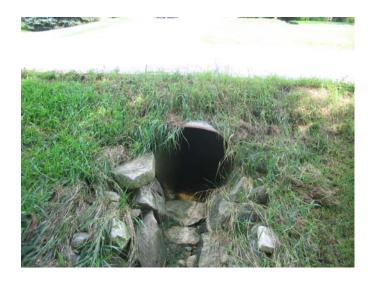
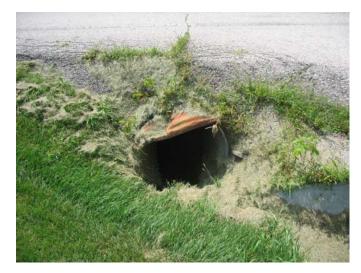
MUNICIPALITY Village of Sussex	PROJECT NUMBER <u>2092194.100</u>
LOCATION (Road/Intersection) 800' East of Wo	•
INSPECTED BY: Kyle Zastrow	_DATE: <u>7/27/10</u>
1. Number of Cells: ☑ 1 ☐ 2 ☐ 3 ☐ 4 ☐ 5 ☐ Other	2. Alignment with road: ⊠ Perpendicular □ Angled NW □ Angled SW □ Angled NE □ Angled SE
3. End Section: ☐ Spalling, Cracking or Chipping ☐ Rust/Corrosion ☐ Peeling Paint ☐ No End Section	4. Joints: ☐ Spalling, Cracking or Chipping ☐ Corrosion ☒ Rust
5. Headwalls: ☐ Spalling, Cracking or Chipping ☐ Rust/Corrosion ☐ Peeling Paint ☐ No Headwalls	6. Debris:

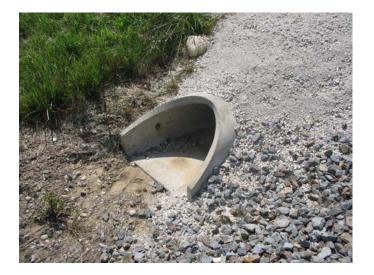
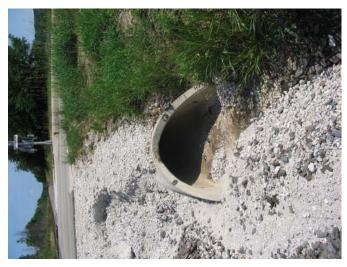
MUNICIPALITY Village of Sussex	PROJECT NUMBER <u>2092194.100</u>	
LOCATION (Road/Intersection) East of Railroad Tracks and Good Hope Intersection (ST 242003)		
SHAPE Round 15-inch MATERIAL Concrete	LENGTH 70' COVER (FEET) 1.5'	
INSPECTED BY: Kyle Zastrow	DATE: 7/27/10	
1. Number of Cells: □ 1 □ 2 □ 3 □ 4 □ 5 □ Other	2. Alignment with road: ⊠ Perpendicular □ Angled NW □ Angled SW □ Angled NE □ Angled SE	
3. End Section: ☐ Spalling, Cracking or Chipping ☐ Rust/Corrosion ☐ Peeling Paint ☐ No End Section	4. Joints: ☐ Spalling, Cracking or Chipping ☐ Corrosion ☐ Rust	
5. Headwalls: ☐ Spalling, Cracking or Chipping ☐ Rust/Corrosion ☐ Peeling Paint ☐ No Headwalls	6. Debris:

ADDITIONAL COMMENTS:	
Gravel/sediment is blocking the end section.
